# EMERGENCY **ALERT SERVICE BULLETIN**

COLIBRI	NUMBER	VERSIONS	
<b>EC120</b>	<b>05A012</b>	Civil:	<b>B</b>

**SUBJECT: TIME LIMITS - MAINTENANCE CHECKS**

Check for crack in the main rotor hub

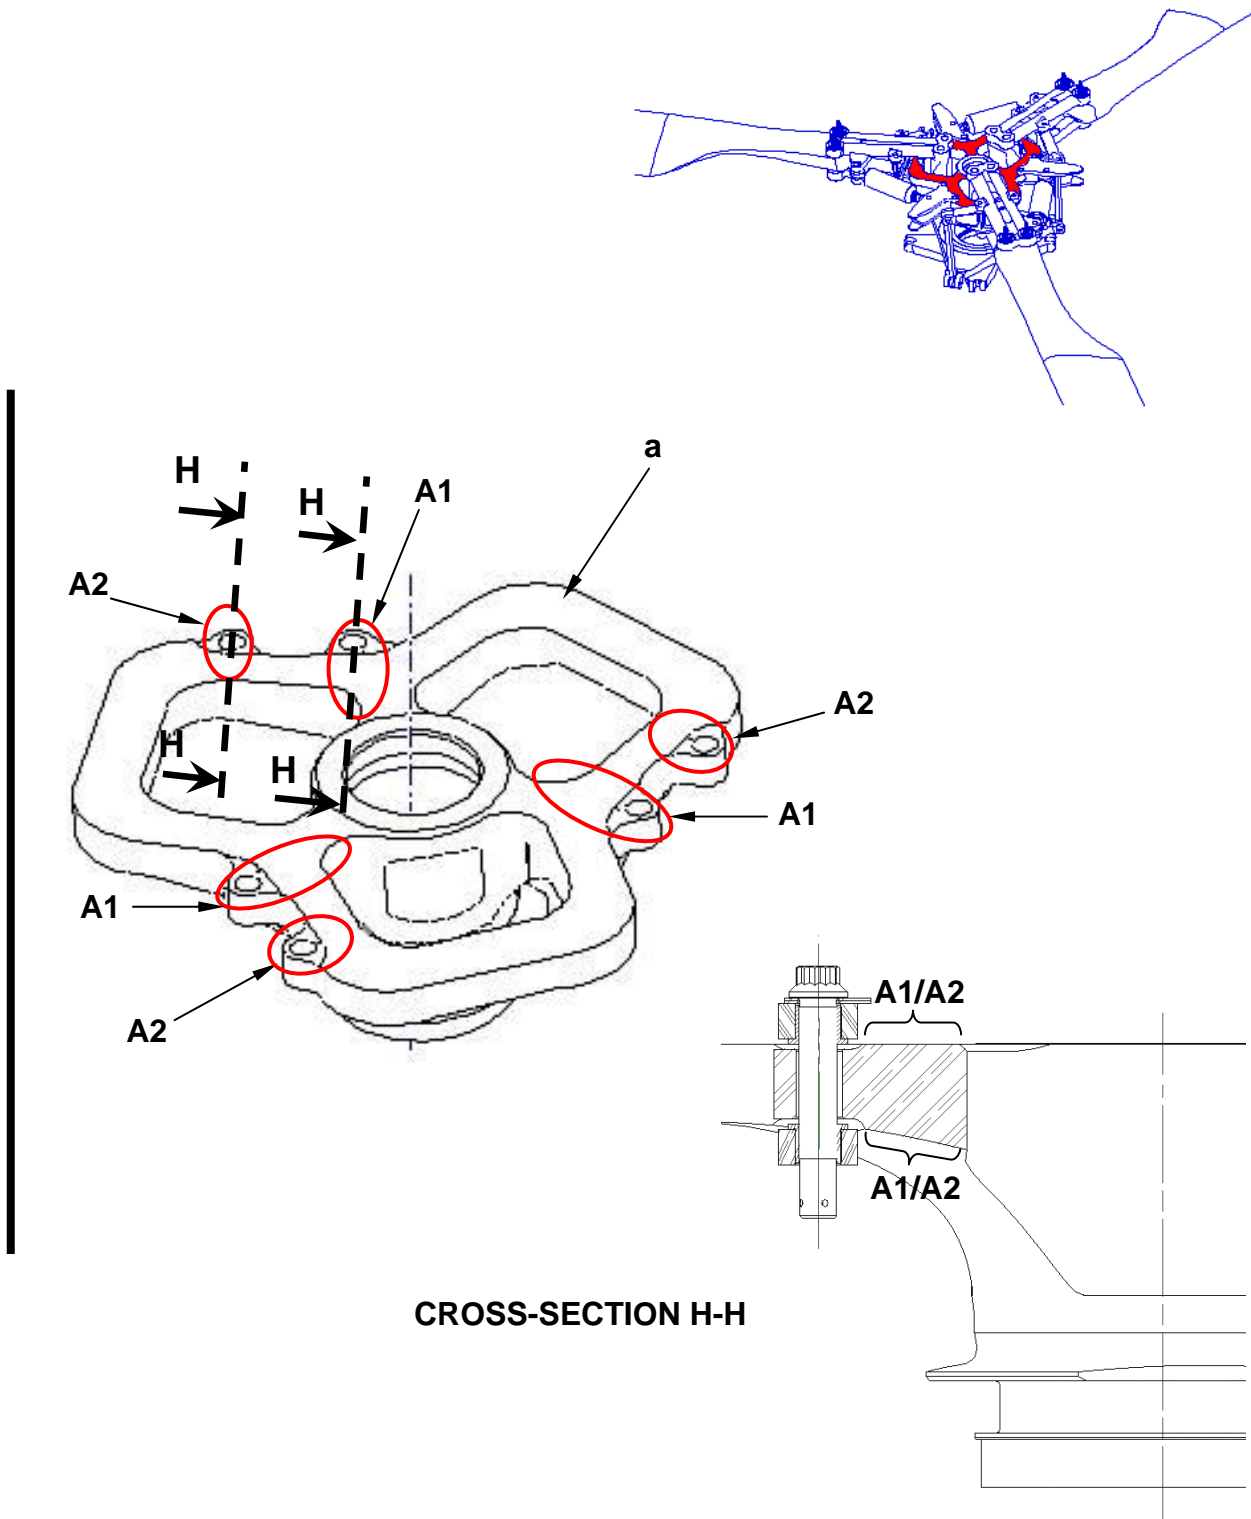
Figure 1: Visual check of the rotor hub

- Visually inspect the inspection areas (A1) and (A2) on the hub (a), and make sure that there is no crack.
- Comply with paragraph 2.B.2.b.

- 1 - If no crack is found:
  - . Install the dome fairing if it was removed previously.
  - . Resume flights.
- 2 - If one or more cracks are found:
  - . Contact EUROCOPTER in accordance with the conditions described in NOTE 1 of paragraph 2.A:

- . Replace the affected rotor hub (a) with a new rotor hub (1a), (1b) or (1c).
  - . Assemble the rotor hub (1a), (1b) or (1c) and install the MRH as per AMM Task 62-21-00, 4-1.

- . Resume flights.
- 3 - If local deterioration is found, leading you to suppose that there could be a crack (scoring, paint spalling, etc.): (as per Figures 1 and 2):

- . Sand the suspected area(s) using No. 600-grit (fine grit) abrasive paper. Remove only the finish paint until the P05 primer coat becomes visible.

- . Once again, visually inspect the concerned area(s), and make sure that there is no crack.
  - . Interpret the results in accordance with paragraph 2.B.2.b.1. or paragraph 2.B.2.b.2.
