AIRCRAFT ACCIDENT REPORT AND EXECUTIVE SUMMARY

Reference:	CA18/2/3/8505	
Aircraft Registration	ZS-RKW	Date of Accident	31 May 2008		Time of Accident	1221Z
Type of Aircraft	Robinson R44 Astro (Helicopter)		Type of Operation	Domestic Charter flight		
Pilot-in-command Licence Type		Commercial Pilot	Age	52	Licence Valid	Yes
Pilot-in-command Flying Experience		Total Flying Hours	1824.1		Hours on Type	39.14
Last point of departure		An open field next to North Road in Kroonstad.				
Next point of intended landing		Loubser Park Sports Stadium in Kroonstad.				
Location of the accident site with reference to easily defined geographical points (GPS readings if possible)						
On a public road in Kroonstad (GPS Position: S27° 38.913" E027° 13.914).						
Meteorological Information		Surface Wind: 270°/10kts; Temperature: 21°C Visibility: CAVOK				
Number of people on board	1 + 3	No. of people injured	1	No. of people killed	0	
Synopsis						
<p>The pilot, accompanied by three passengers, departed from an open field next to a public road in the City Centre of Kroonstad. The three passengers were members (actors) of a local television production. The pilot stated that after take-off, one of the

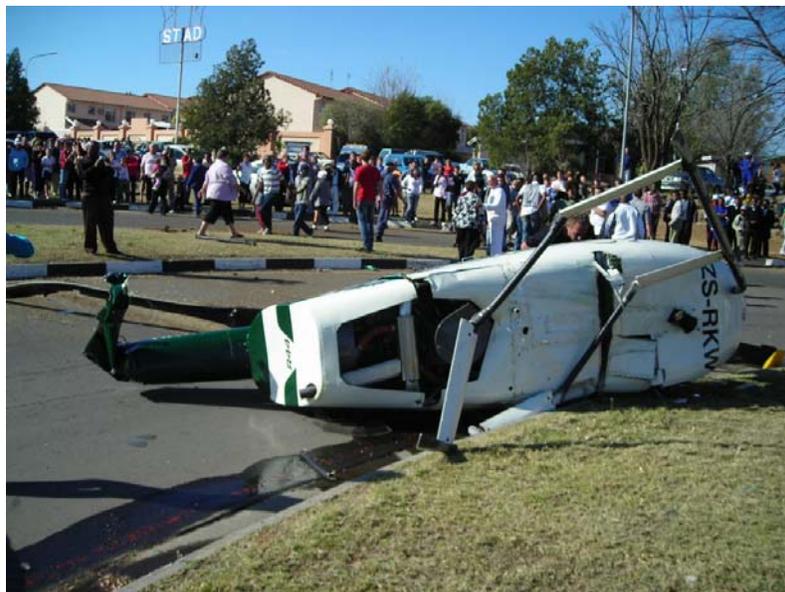
- 1.3.1 The helicopter sustained substantial damage to the main rotor blades, tail boom, tail rotor blades, the skids, the under-surface of the helicopter, the left-hand side of the helicopter, and the left-hand windscreen of the helicopter, on impact with the ground.

Figure 1: A view of the main wreckage

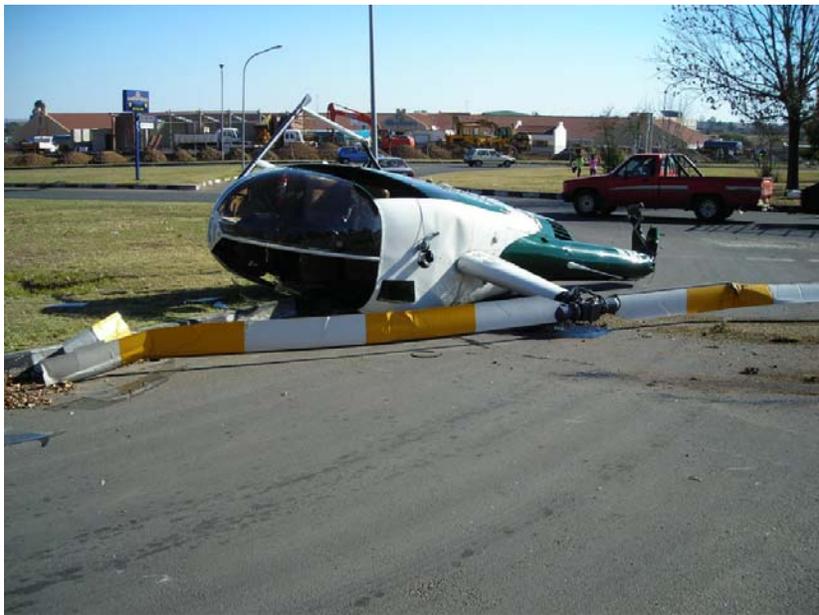
Figure 2: A view of the main wreckage from the opposite side

1.12.2 The helicopter sustained substantial damages to the main rotor blades, tail boom, tail rotor blades, the skids, the under-surface of the helicopter, the left-hand side of the helicopter, and the left-hand windscreen of the helicopter, on impact with the ground.

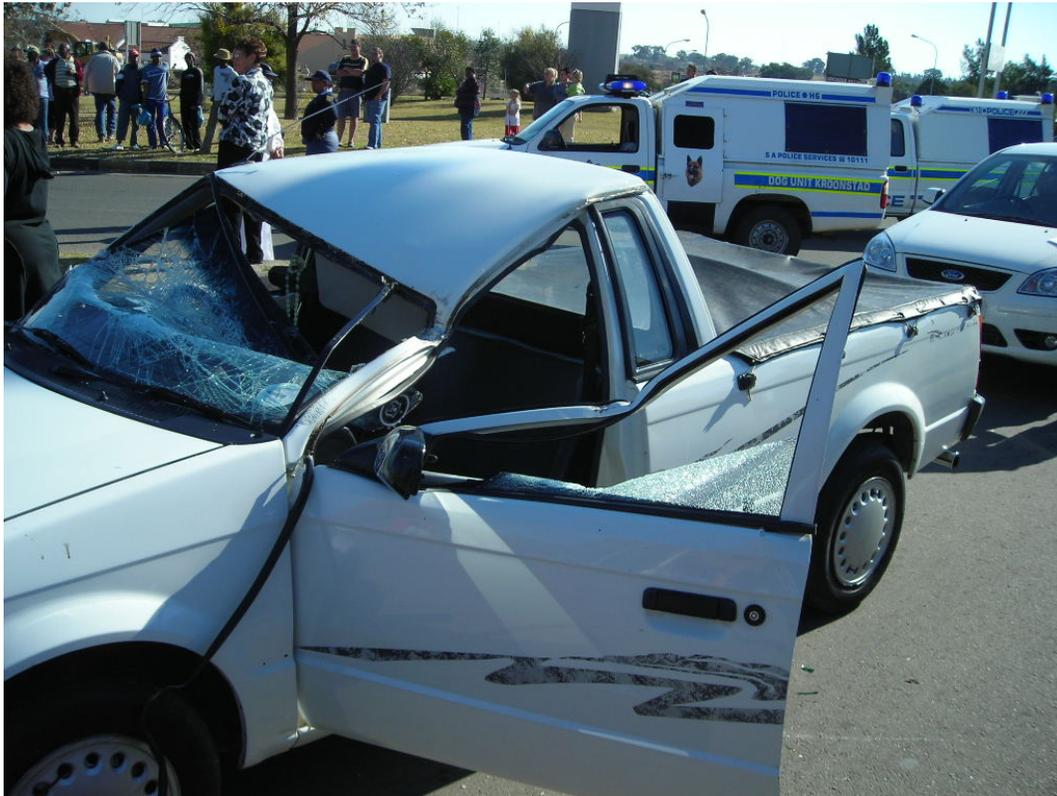
- 1.4.1 During the impact sequence, the helicopter impacted a vehicle which sustained substantial damage.

Figure 3: Indicates the damages that the vehicle sustained.

1.12.3 The helicopter collided with a vehicle travelling on a road. The vehicle sustained substantial damages to the roof, left-hand door and front windscreen.

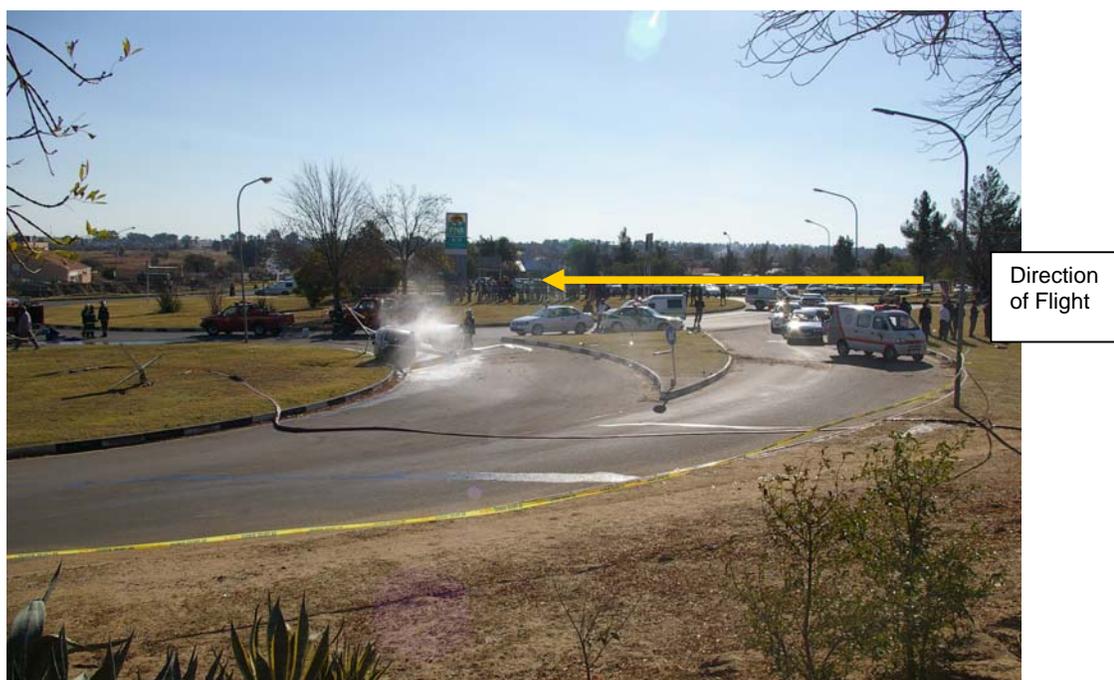
1.12.1 The helicopter was flying in a southerly direction before the tail rotor impacted with the ground. Ground marks indicate that the tail rotor impacted the ground 12 metres before the helicopter collided with a light delivery vehicle which was travelling on a public road in an easterly direction. The helicopter came to rest on its left-hand side 17 metres past the vehicle facing in a south-easterly direction.

Figure 6: Indicating the wreckage lying on its right-hand side in a public road. The yellow arrow indicates the direction of flight. The photo further shows the aircraft being sprayed with foam after the accident.

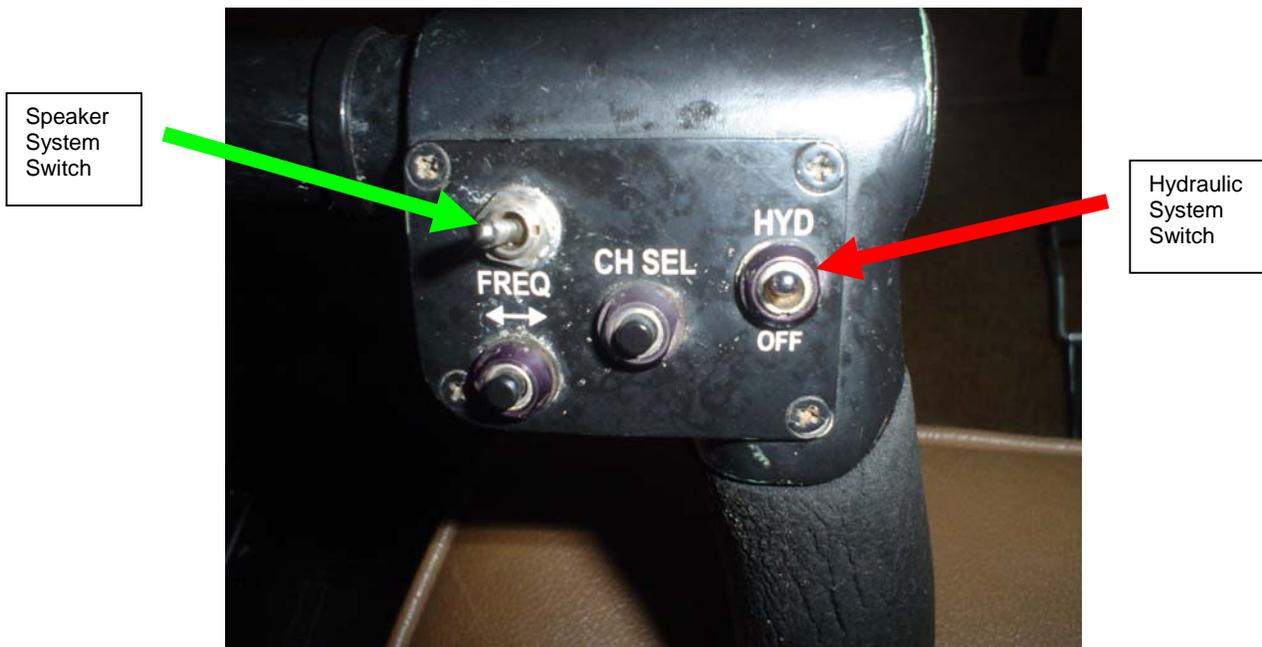
1.6.4 Cyclic control stick

Figure 4: The green arrow indicates to the speaker system switch. The red arrow indicates to the hydraulic switch on the cyclic control stick. Note that the 2 switches look exactly the same.

It was, however, possible that the pilot wanted to switch on the speaker system (switch being on the cyclic stick) in order to entertain the crowd, but in the process unintentionally switched off the hydraulic switch also installed on the cyclic stick. The two switches looked exactly the same and were unguarded.

- (viii) A passenger sustained serious injuries during the accident.
- (ix) The helicopter was substantially damaged.
- (x) The pilot had inadvertently switched off the hydraulic switch when he attempted to switch on the speaker switch.

3.2.1 Hydraulic system failure as a result of the pilot inadvertently switching off the hydraulic switch.

4.1 It is recommended that the SACAA should introduce requirements that the hydraulic switch be capped, which would require the guard to be moved before the position of the switch is changed.

4.2 Alternatively, the SACAA should recommend to the manufacturer that the position / location of the hydraulic switch be removed (repositioned) from the cyclic control stick to the centre console. The switch should, if possible, feature the detent switch application (switch controls two circuits but with only an open and closed position, the switch needs to be pulled and then moved over the detent to the opposite position in order to activate the circuit) as can be seen in Figure below (left bottom of the panel HYD SYS, applicable to the Bell 407 type helicopter).

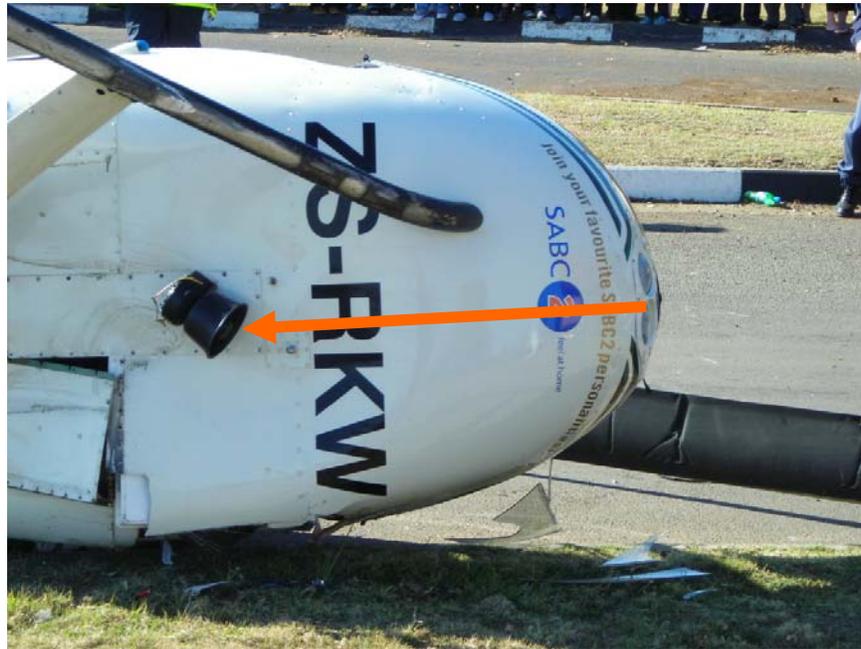
During the investigation no records of a modification approval was found for the fitment of the speaker system that was found on board the helicopter.

Figure 7: The arrow indicates the speaker attached to the helicopter.

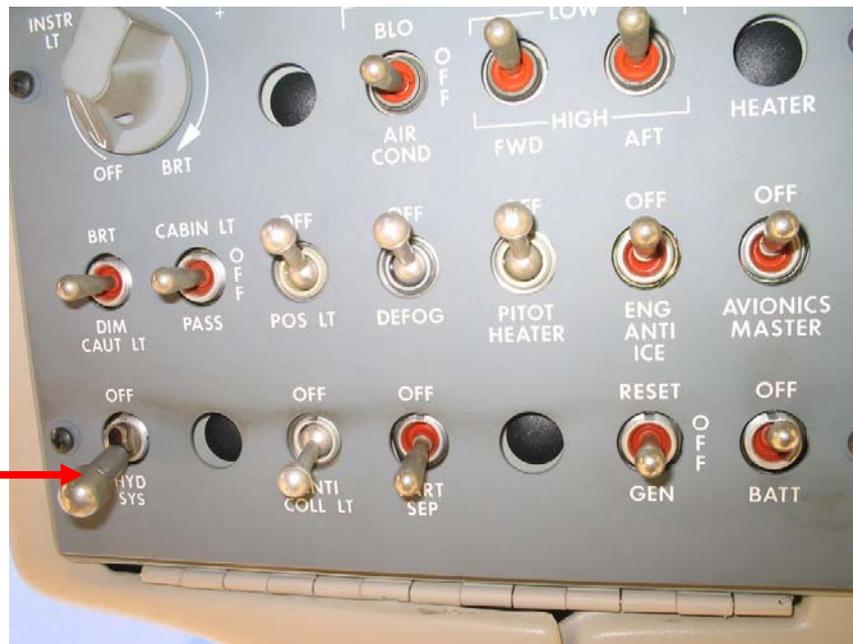
Figure 8: A view of the HYD SYS switch located on the overhead console of a Bell 407.
